Terra Vigilis Environmental Services Group

Water Quality and Wave Impact Study
Phase 2 Report

Prepared for the North Lake Management District

July 20, 2022

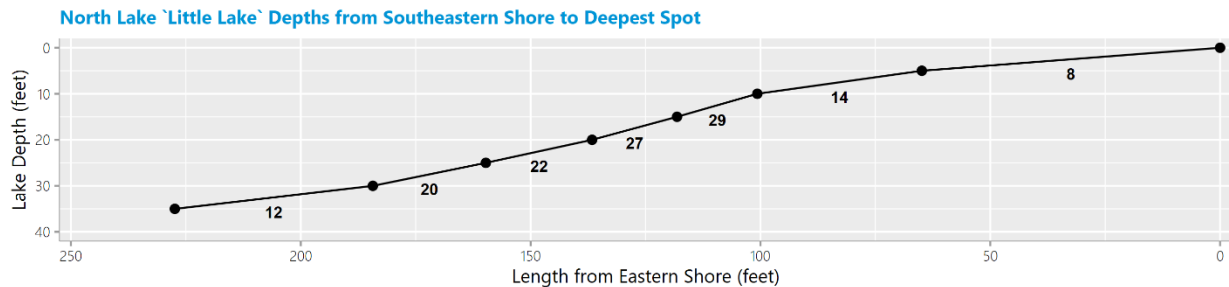
Figure 12A: Enlarged nearshore area of Figure 12

A depth of 35 ft is about 250 ft from shore. The maximum depth of 75 ft is about 1150 ft from shore. Calculated slopes are shown underneath the line between each 5-foot depth increment change. Source: SEWRPC.

It is important to note that shoreline slope can also affect wave characteristics. In the video footage, there is a light-colored bench (shelf) that contains shallow water compared to the darker colored deeper waters. This lighter colored bench is roughly where the 5-foot water depth transitions to deeper darker water. As shown in Figure 12 this bench from the shoreline to 5-foot depth is flatter or comprised of a gentler (8 percent) slope than the deeper parts of the lake, except when waters exceed 60 feet in depth. This bench is characteristic of the entire shoreline of North Lake in both basins and is largely comprised of sand substrates. Carroll University students determined that substrates within this bench

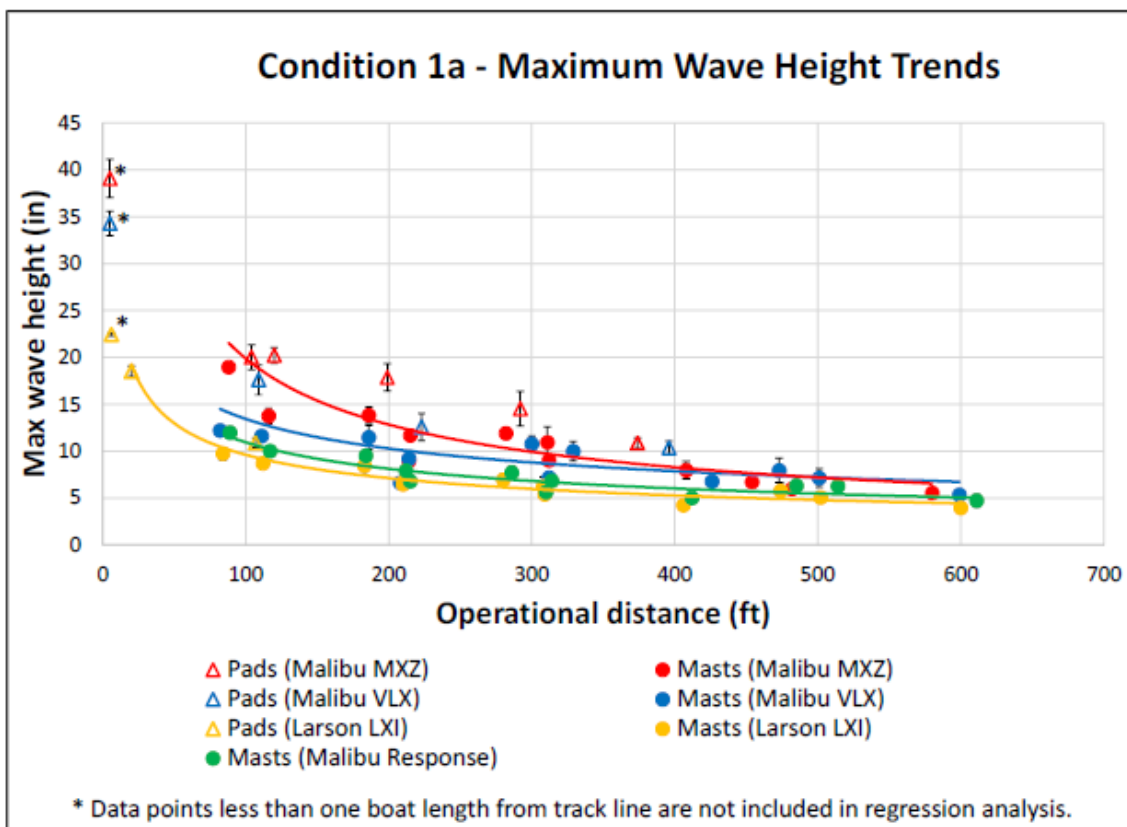
Since the wave measurements were taken 15 meters or 50 feet from the shoreline of the little basin of North Lake, that would equate to a water depth of about 2' to 4'. This indicates that the waves generated from each vessel being measured were being influenced by the bottom of the lakebed (i.e., shallow water wave depth conditions). This likely means that wavelengths were likely underestimated and that wave heights were likely overestimated in this study. Nonetheless, maximum wave height characteristics for wakeboard boats in this study were comparable to the aforementioned University of Minnesota study measured closer to shore. In other words, the wakeboard boat maximum wave height of 10 inches operating 250 feet from shoreline was in agreement or within range reported for maximum wave height generated by a wakeboard boat in full ballast condition between 200 to 300 feet from the operating vessel as shown in Figure 15 from the aforereferenced report below. In that study 200 feet and 300 feet distances from an operating wakeboard boat generated maximum wave heights (depending on the Wakeboard boat model) ranging from about 9 to 19 inches and 9 to 17 inches, respectively.

Figure 15: Condition 1a – Maximum wave heights over operating distance
 Source: University of Minnesota – St. Anthony Laboratory Report: “A Field Study of Maximum Wave Height, Total Wave Energy, and Maximum Wave Power Produced by Four Recreational Boats on a Freshwater Lake” published February 2022.

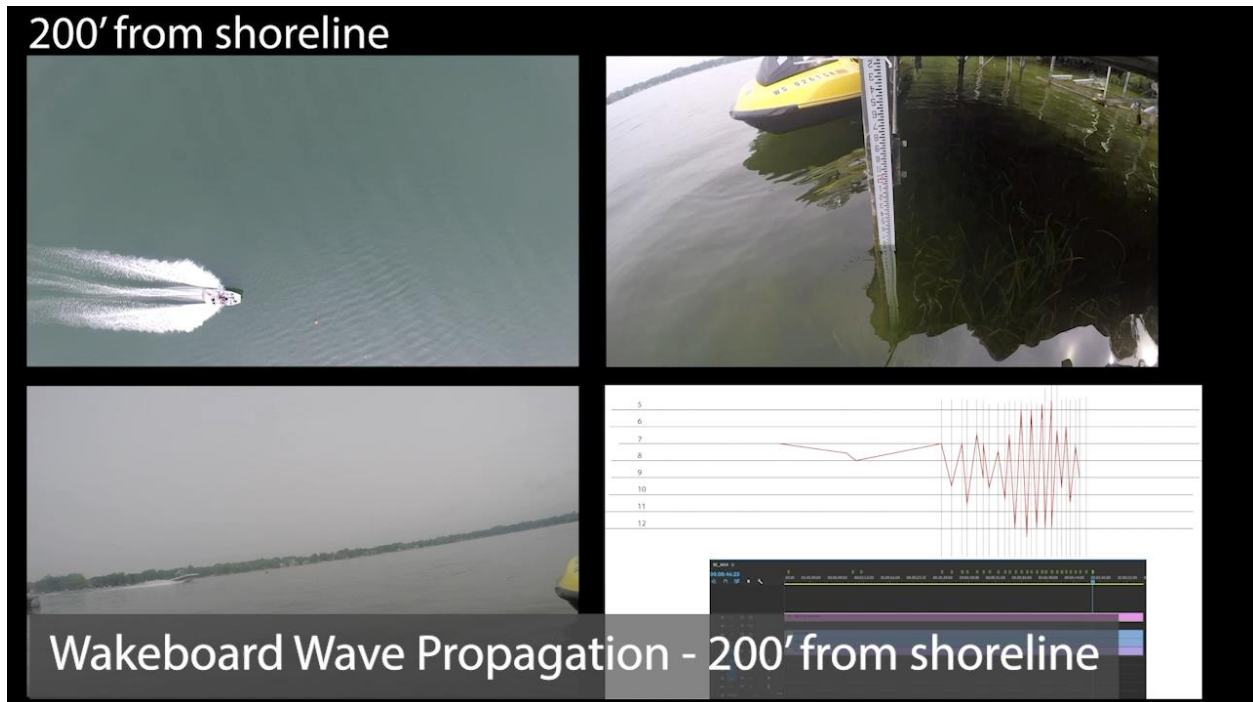
[Figure 17-Video: Comparative Wave Oscillation Data 200' from Shoreline](#)

The wakeboard boat wave propagation comparison shows that all the waves heights are much higher and have great wavelengths and heights from the pass at 200 feet compared to 300 feet from the shoreline.

Although these results indicate a reduction in the wave energy when boats were run 100 feet further from shoreline (i.e., 300 feet versus 200 feet) it is important to note that these wakeboard boat waves are smaller in maximum wave height compared to previous wakeboard boat runs in 2021 and current research as noted above in part due to the wave characteristic measurements being taken in deeper water depths (4-5'). These wakeboard boat passes generated maximum wave heights of 8 inches and 4.5 inches for the 200 feet versus 300 feet passes, respectively. In 2020 the wakeboard boat run 250 feet from shore generated a 10 inch maximum wave height in 18-24" of water depth (see above). In addition, the Minnesota study reported wave heights ranging from about 9 to 19 inches and 9 to 17 inches 200 feet and 300 feet distances from an operating wakeboard boat depending on the wakeboard boat model, respectively. The 2021 video at 200' show the initial waves of the wave packet breaking before reaching the shoreline, however it cannot be seen from the video footage if sediments were disrupted in the nearshore area (as compared to the 2020 aerial videos). At 300' the waves do not appear to break until reaching the shoreline and therefore remained smaller rolling waves. Hence, these recorded waves do not show direct impact on the nearshore area or shoreline of North Lake (as compared to the 2020 4-Quadrant videos from the Phase 1 Study).

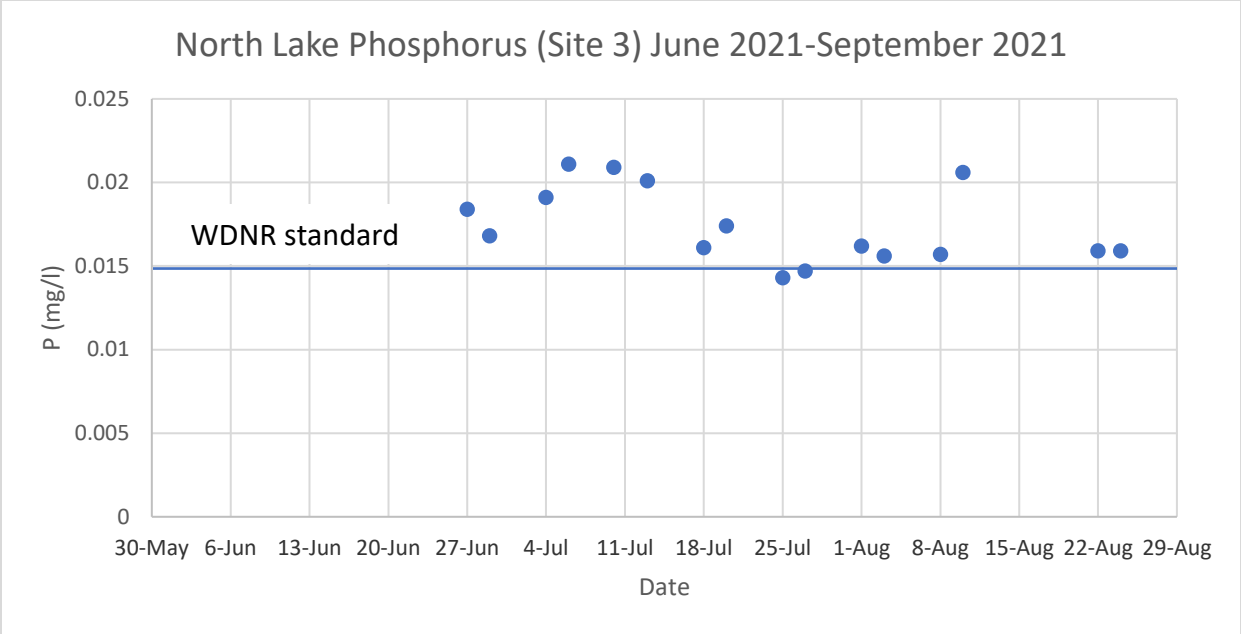
For each of the figures with timelines (Figs. 1,2,3,4,5) the major gridlines on the X axis represent Sundays with one-week intervals. High traffic weekends are shown on or immediately preceding the major X axis gridline. Low traffic weekdays (typically Tuesdays) are shown 2/7th across an interval.

Figure 1: Total Phosphorous

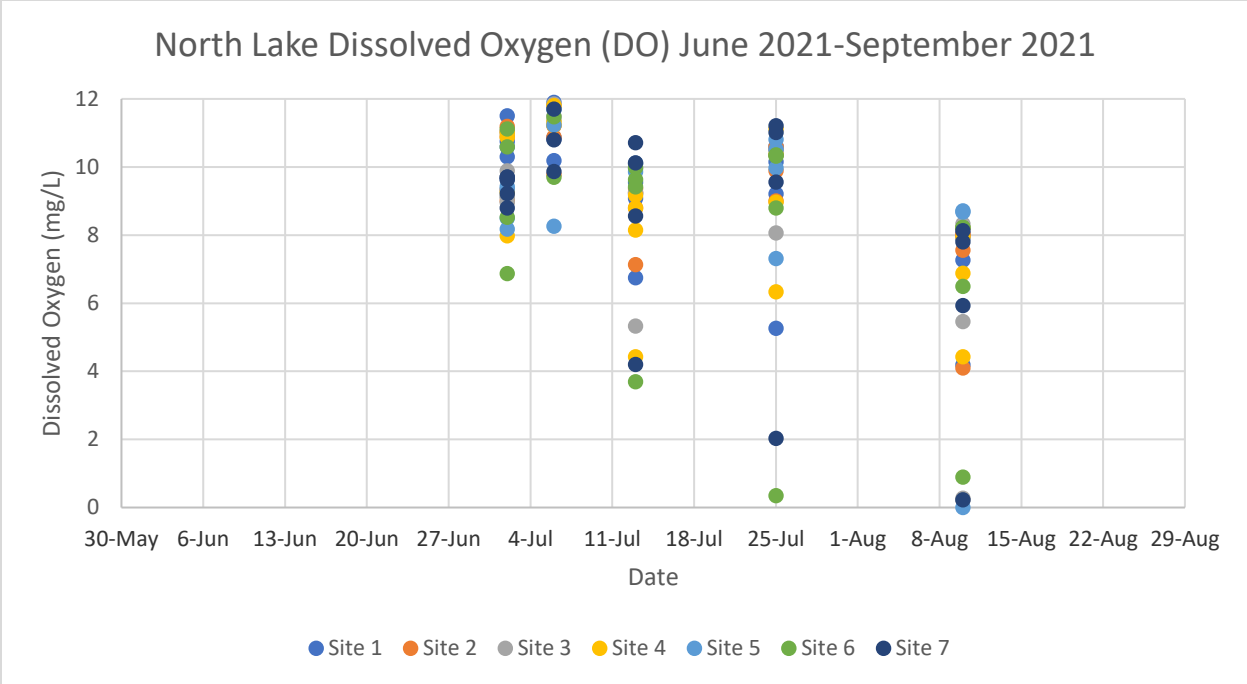
Figure 2: Dissolved Oxygen

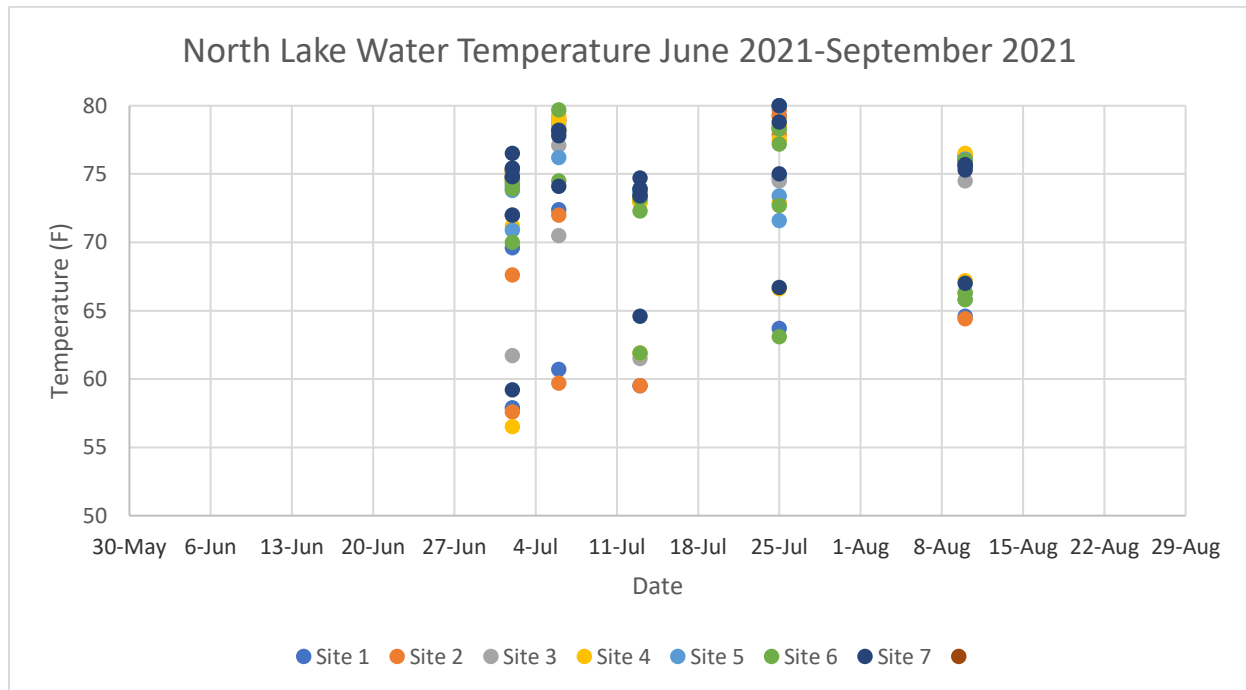
Figure 3: Water Temperature

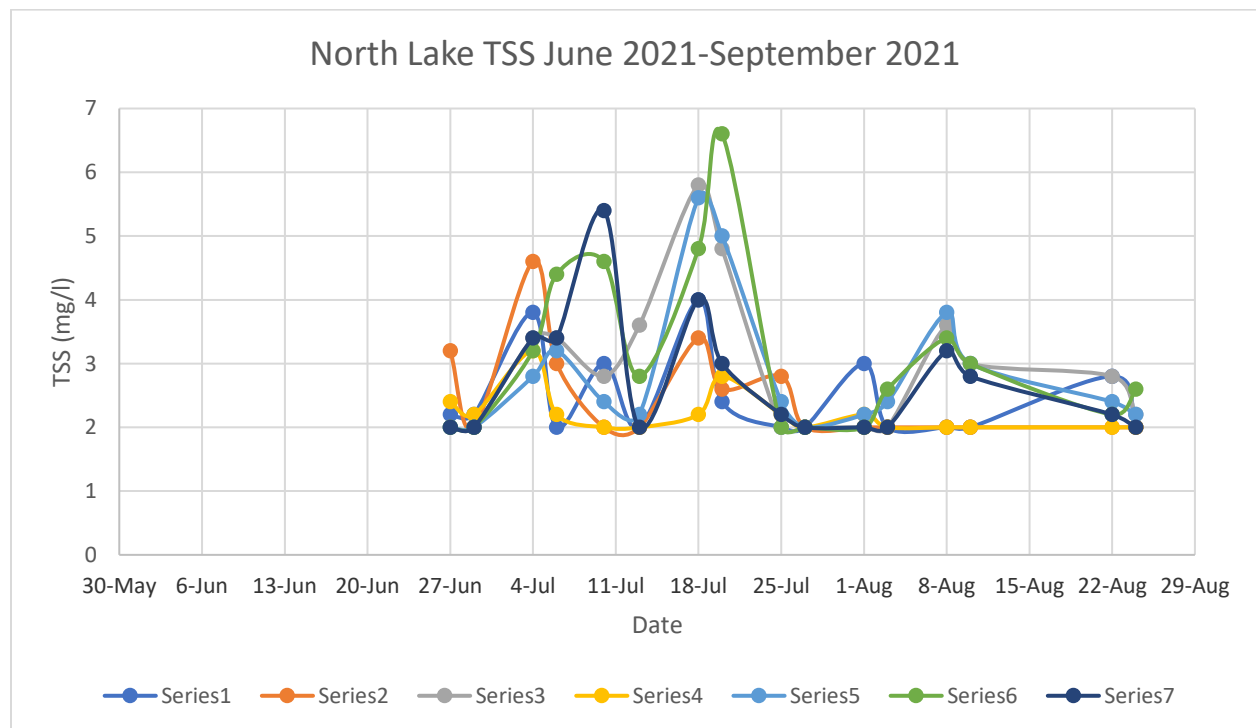
Figure 4: Total Suspended Solids (TSS)

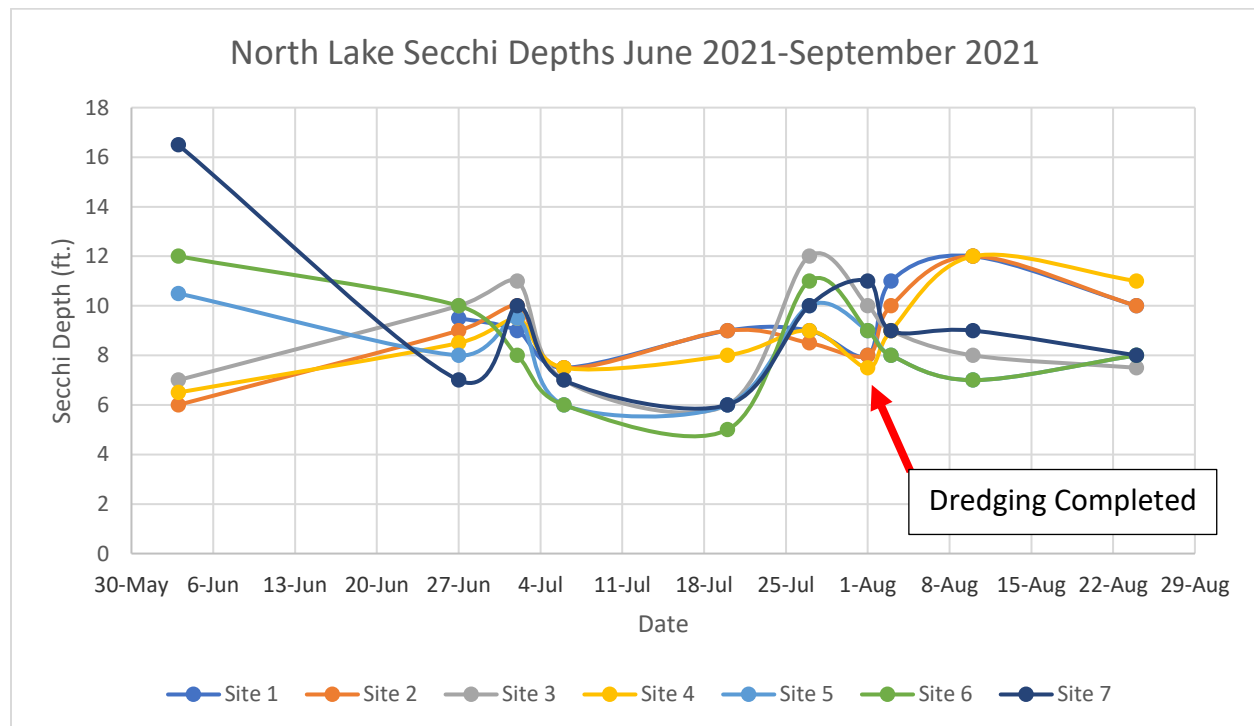
A small decrease in water clarity occurred at Site 4 near the channel during channel dredging operations (July 26-Aug 3) and recovery was noted within 1 week in this area.

Figure 5: Secchi disk measurements
